HO-956
10437 Clarksville Pike (Rt. 108)
Columbia vicinity

Maryland Inventory of Historic Properties Form

Inventory No. HO-956

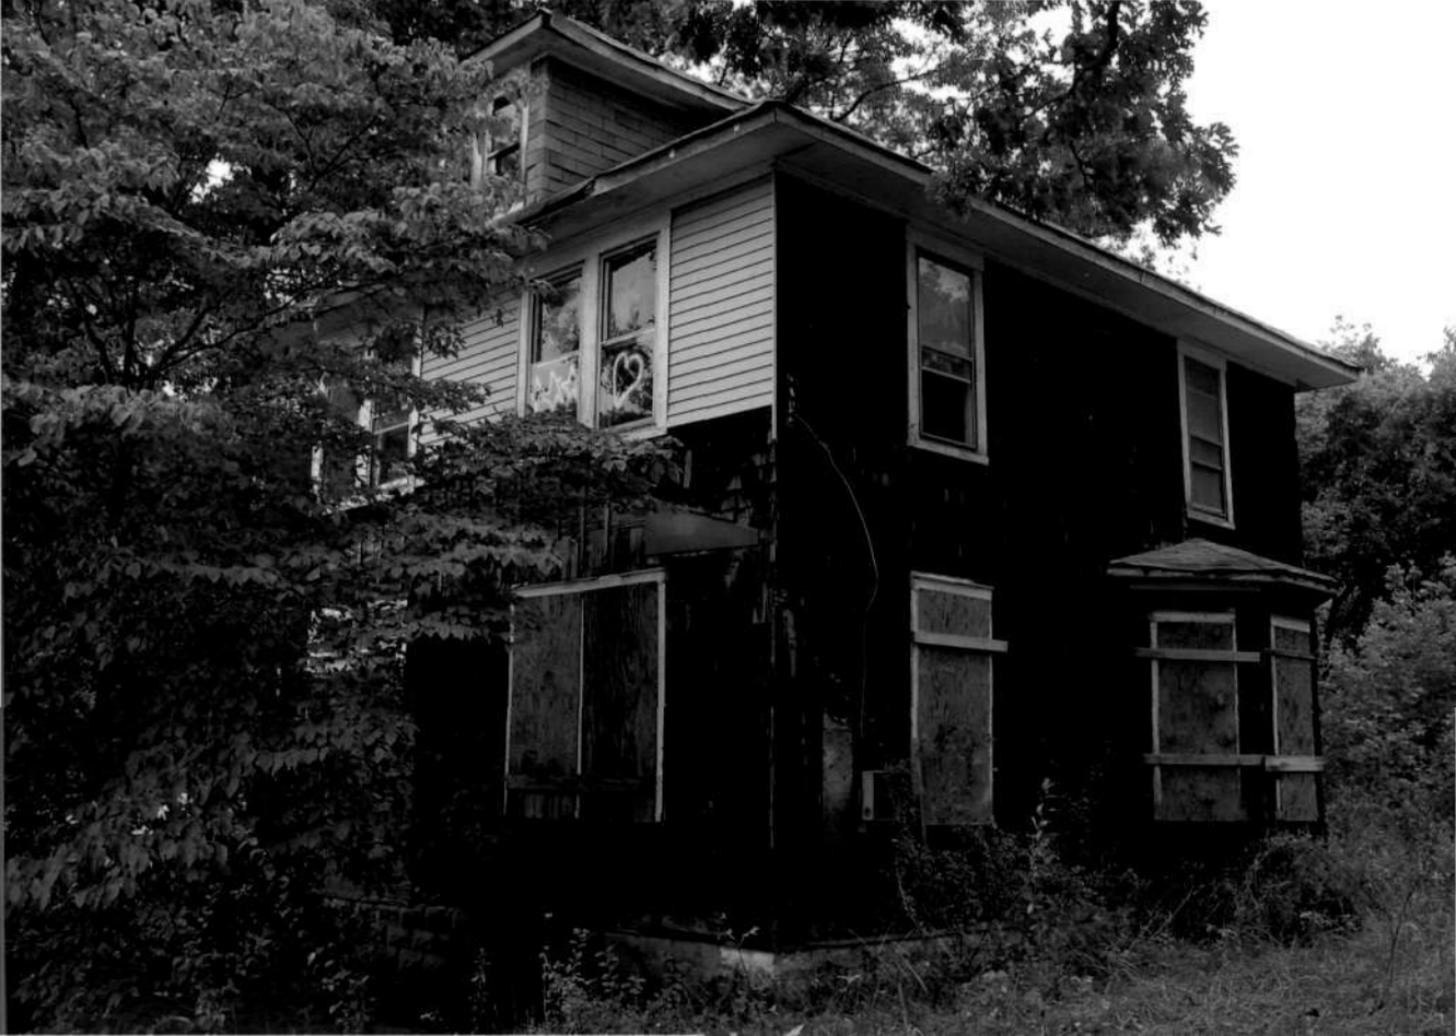
1/2

On the north elevation, the first story has a boarded-up doorway with a transom in the east bay and a boarded-up double window in the west bay. There was a one-story, two-bay porch here that had a hip roof, but no part of it survives beyond the ghost on the wall. The second story has two paired one-over-one sash with head-cut trim. There are wide overhanging eaves that have narrow board soffits and some plywood replacement. There is a hip-roofed dormer with paired one-over-one sash. On the east elevation, the north bay has a boarded-up window in the foundation and a small boarded-up window on the first story. The north-center bay has a doorway at grade that is boarded-up, and a small window set between the first and second stories, suggesting that the stairs must ascend to the south along the east wall. The south-center bay has a boarded-up window on the first story and a one-over-one sash with head-cut trim on the second. The south bay has a boarded-up window in the foundation and first stories and a one-over-one sash with head-cut trim on the second.

House, north and west elevations

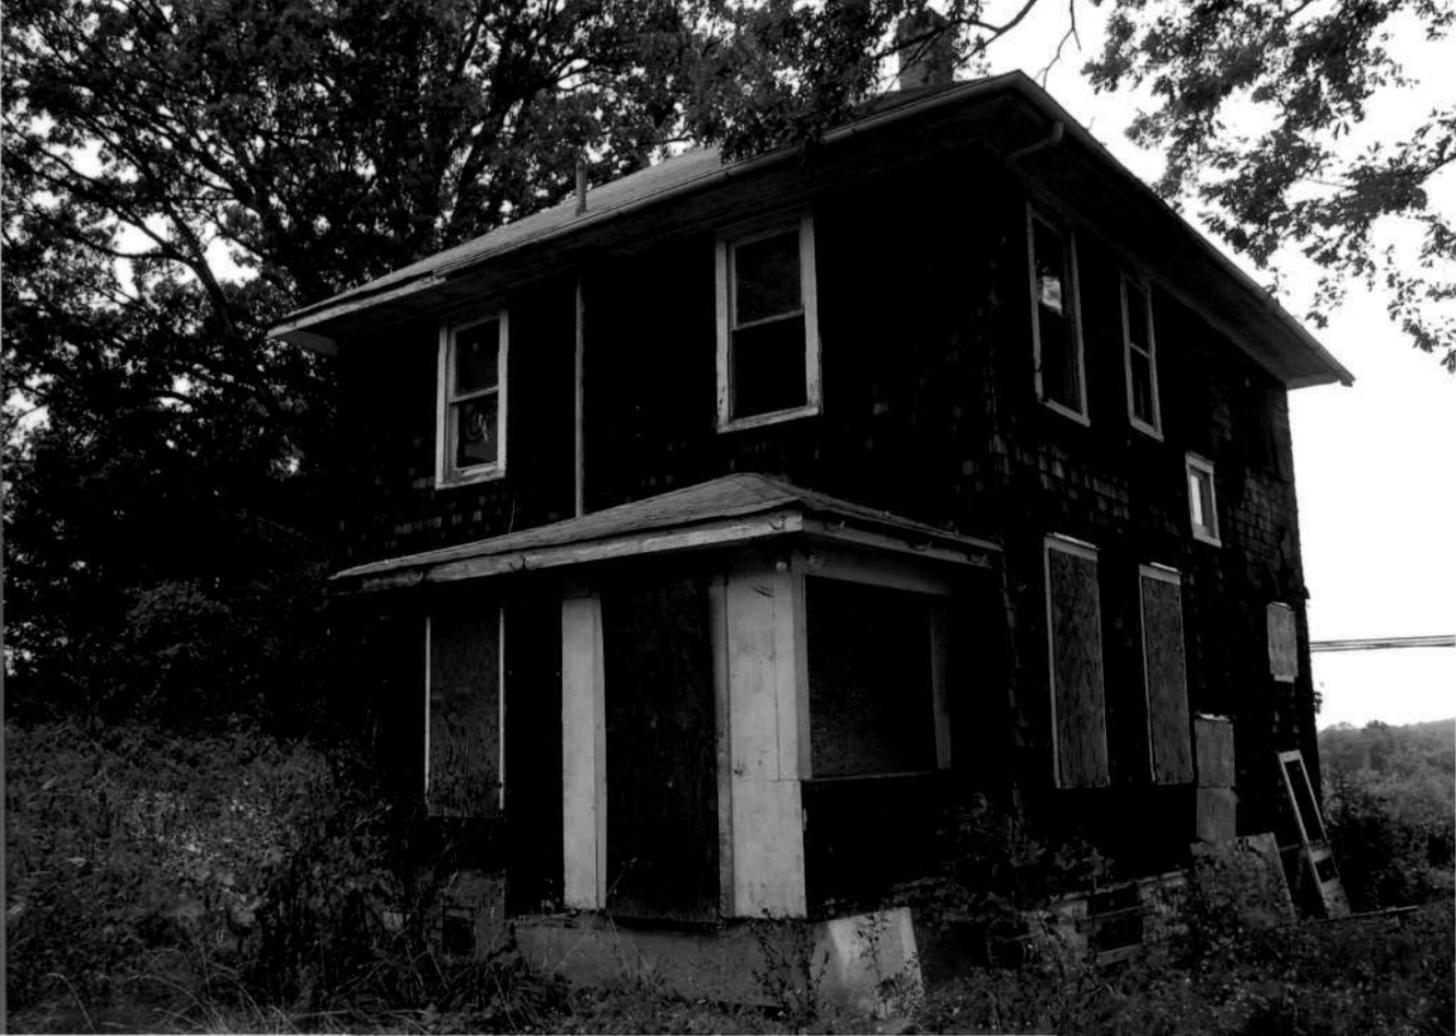
The south elevation has a one-story, two-bay by one-bay wing that must be set on piers, since there is open space in the foundation, though most of it is hidden by boards. This wing has wood shingles and a hip roof. There is a boarded-up wide window on the east elevation. On the south is a boarded-up window to the west and a boarded-up door to the east. The west elevation has no openings. On the main block the west bay has a boarded-up window on the first story and two one-over-one sash on the second story. The west elevation of the main block is two bays. The first story has a boarded-up window to the north and a one-story, three-sided bay to the south, with boarded-up windows on each side of the bay. There is a foundation under the bay. The second story has two one-over-one sash with head-cut trim.

House, south and east elevations
2/2
